Scraper cross slope appears to be the opposite of what it should be.

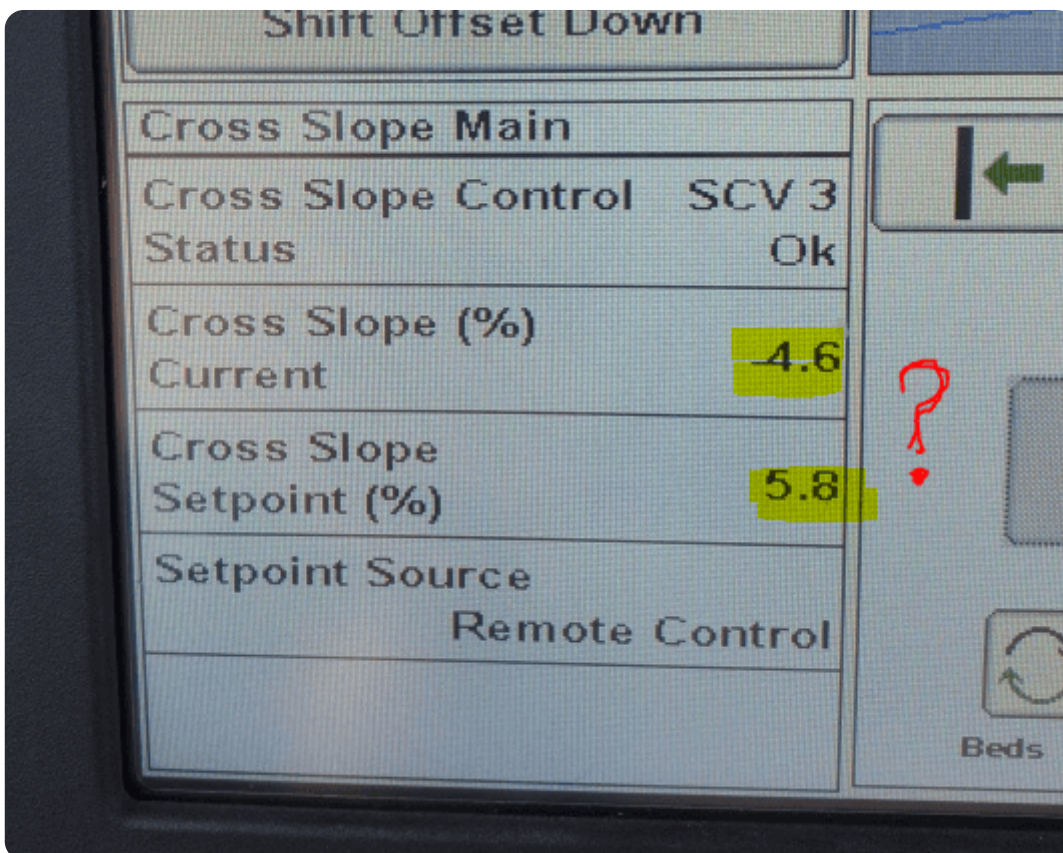
When T3RRA is commanding a cross slope tilt to one side the scraper blade is doing the opposite. iGrade is showing a current cross slope % as positive when the implement is rolled to the left, and negative when tolled to the right. Reversing hydraulic hoses in the remotes does not help the problem.

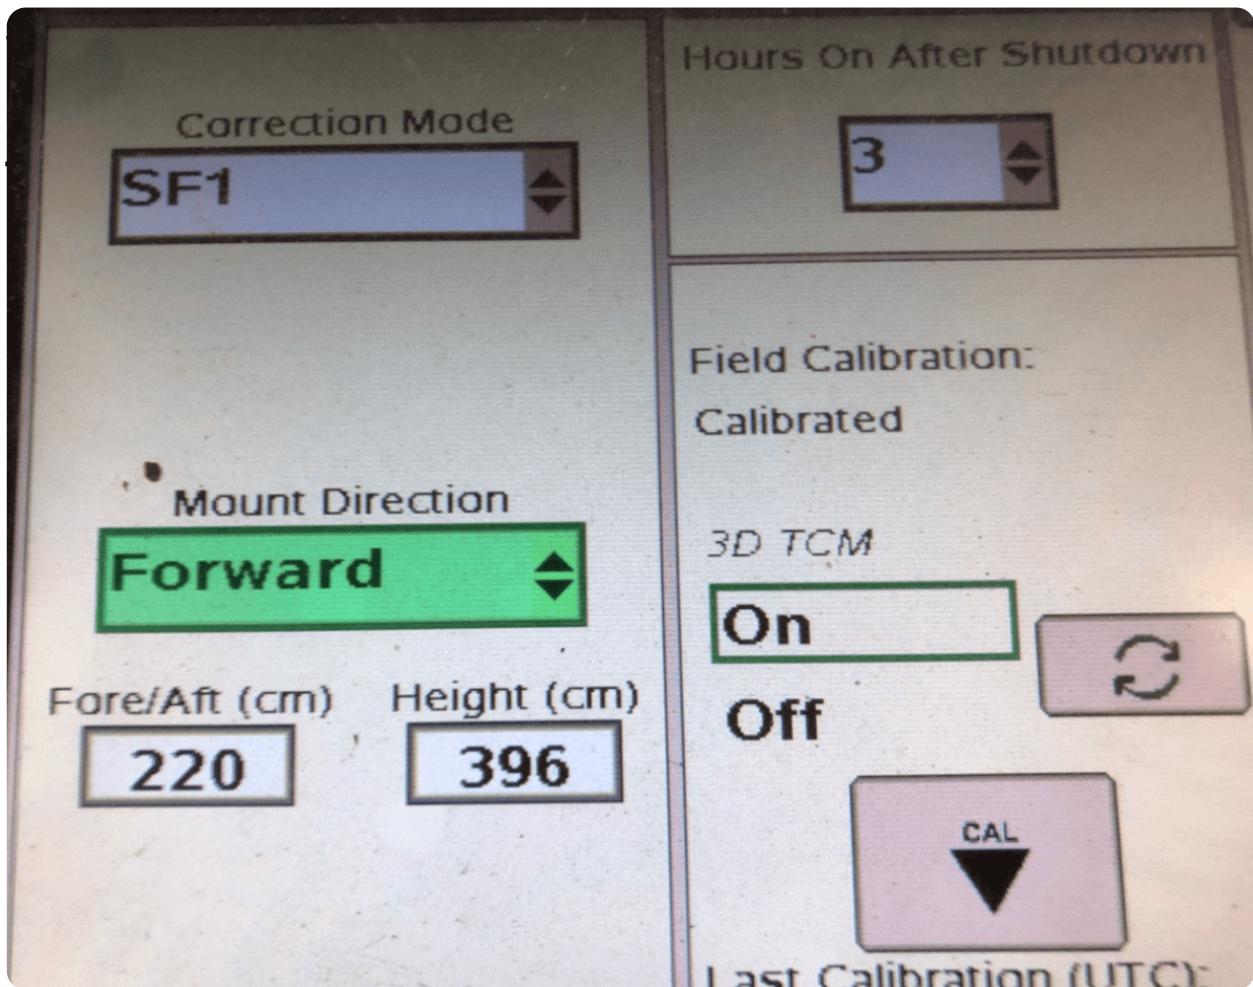
The implement GPS mount direction has been changed to 'Backward' in the John Deere display. This causes receiver TCM readings to be the opposite of what they should be.
