Implementing issues - T3RRA

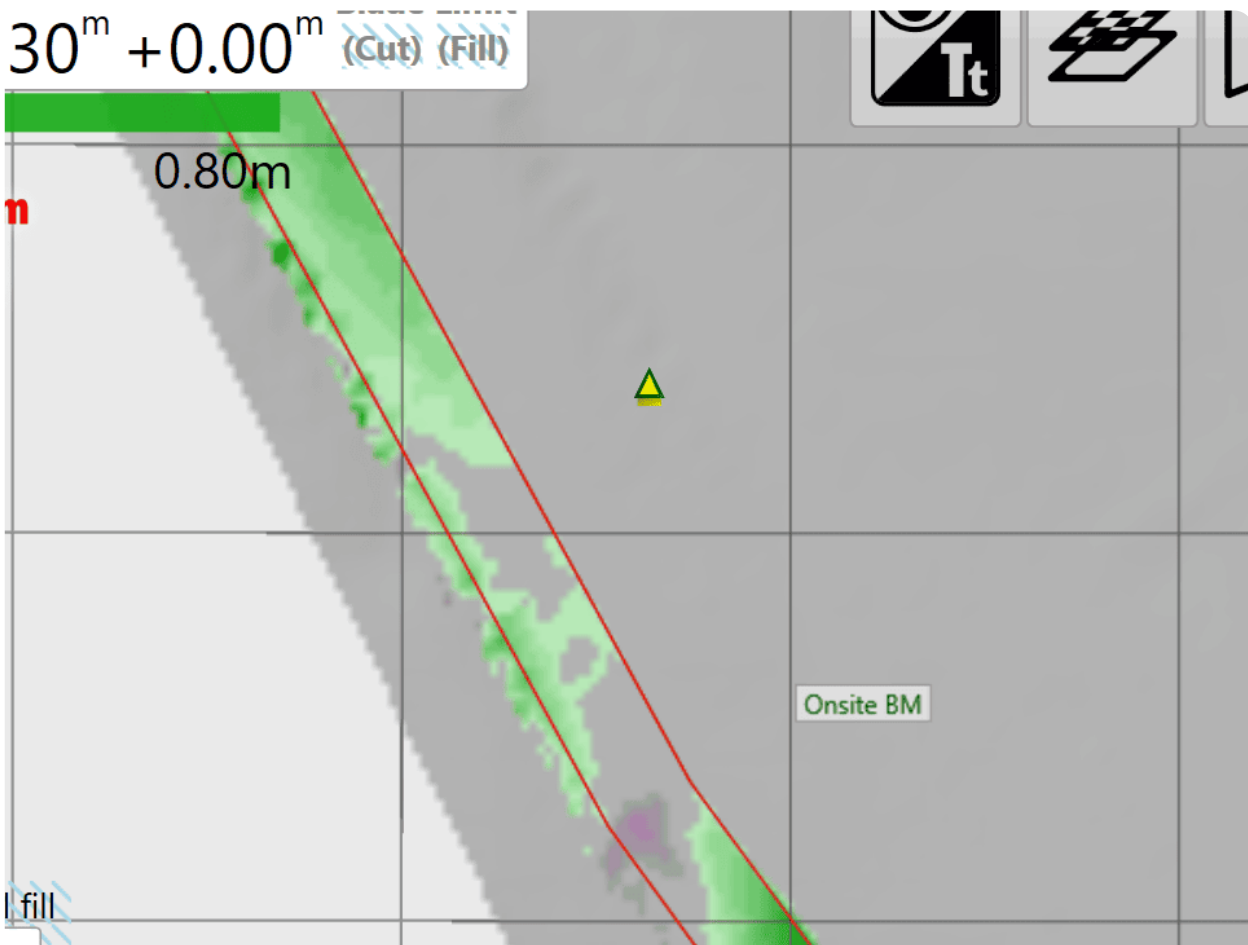
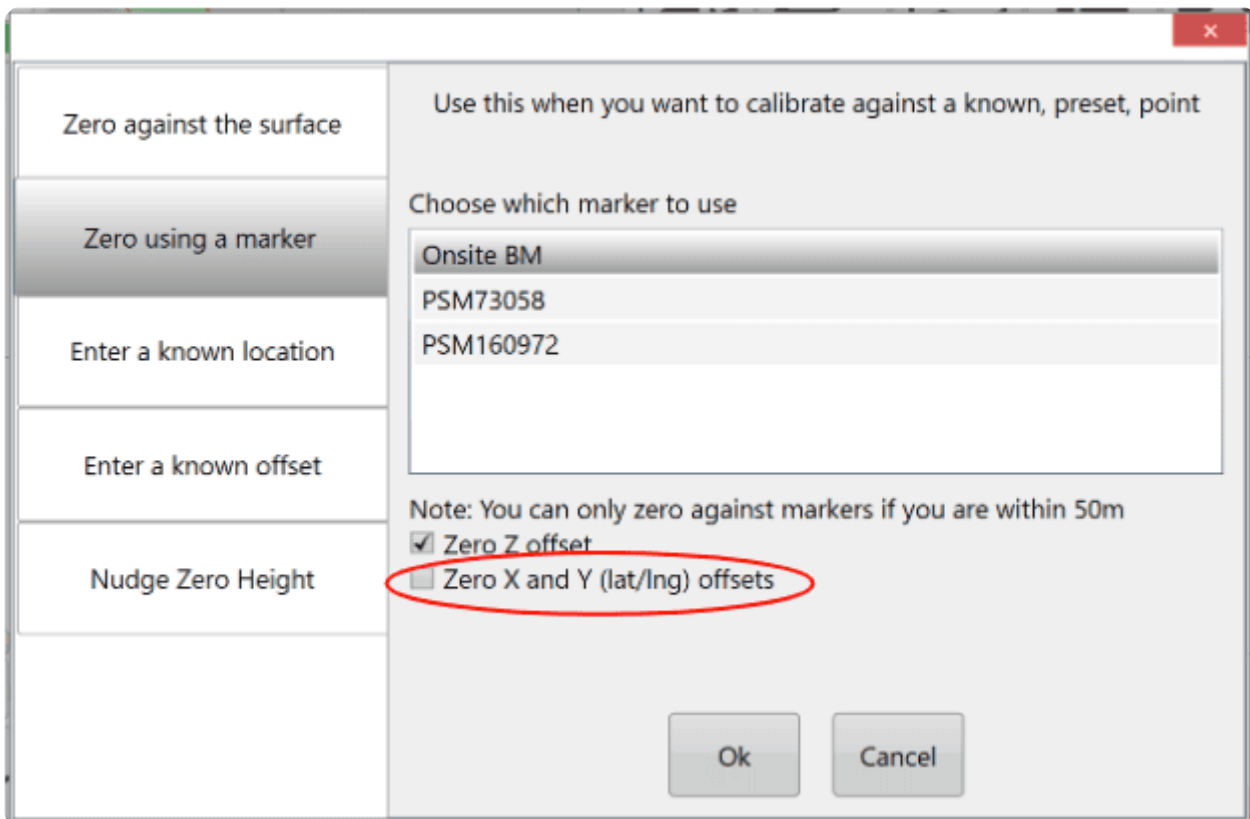
Tractor position icon does not adjust when you zero against a benchmark.

You are parked over a physical benchmark and want to adjust the map location so that the related on-screen benchmark icon matches the location on the tractor icon. However when you perform the “Zero using a marker” action nothing changes. The icons for the benchmark and the tractor remain separated.

You have forgotten to check the “Zero X and Y (lat/Ing) offsets” box.

Check the “Zero X and Y (lat/Ing) offsets” box before pressing the Ok button.

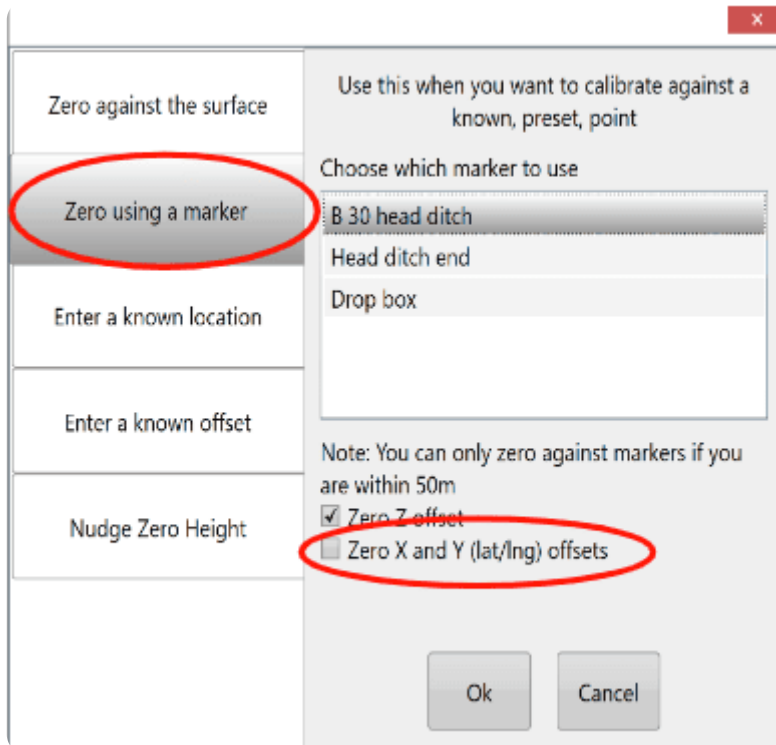
Project has moved N/S or E/W.

When you return to an existing job the map is no longer aligned with the position of the tractor. The project surface has moved North/South or East/West.

- **Previously entered offsets have been cleared under the Machine tab in settings.**
- **The Base station has been moved.**
- **The Base station is configured as a Quick survey and has been power cycled or reset.**

1. **Keep a record of any horizontal offsets you have used for a project in case you need to re-enter them. If you look back in the project 'activity log' you may be able to find previously entered ones there (depending on version).**
2. **Always use a Base configured as 'Absolute Base' where possible**
3. **Reference any newly established base station from a "dealer network" or permanent base network where possible**

4. **If using a 'Quick Survey' have it connected to a permanent and always-on power source for the entire duration of a job.**
5. **Never move a Base station position during a job.**
6. **Establish permanent "benchmark" locations to check against and re-align the job. You can use the regular 'Zero' button in the implementation screen for this.**

7. **Use T3RRA software offsets to re-align the map.**

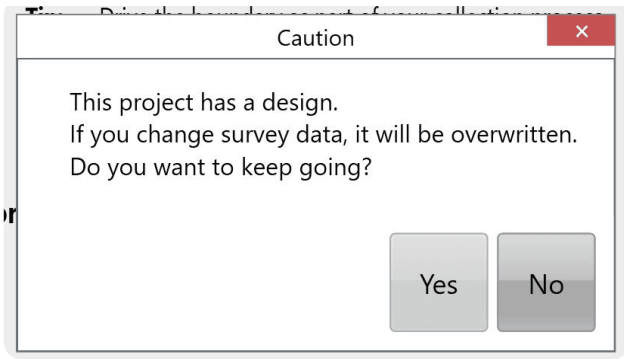
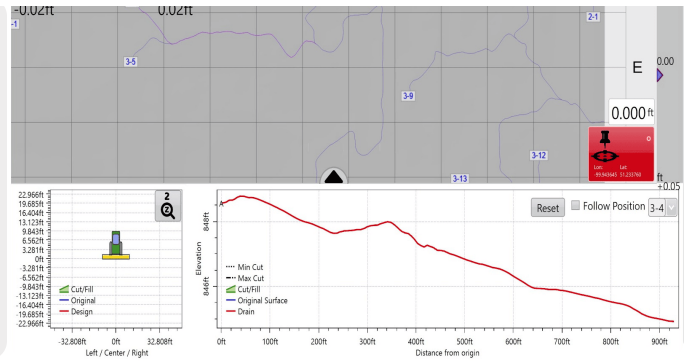
My drain design is no longer present in the 'Apply' wizard step.

The Cut/fill map of drain surface in the Apply step is representing no cut and no fill.

The profile view in the Apply step of the drain is a solid red line.

A drain design was created for one or more of the multiple drains in one project and the user went back to the Collect step and recorded another drain survey within the same project.

All drain designs were 'overwritten' when returning to Collect step to add more drains to the same project.

Design and Implement one drain at a time saving each as one project file.

Design and Implement each drain completely within one project before adding more drains.

Survey all drains, design them, and finally implement them without returning to add more drains.
