Implementing issues - T3RRA

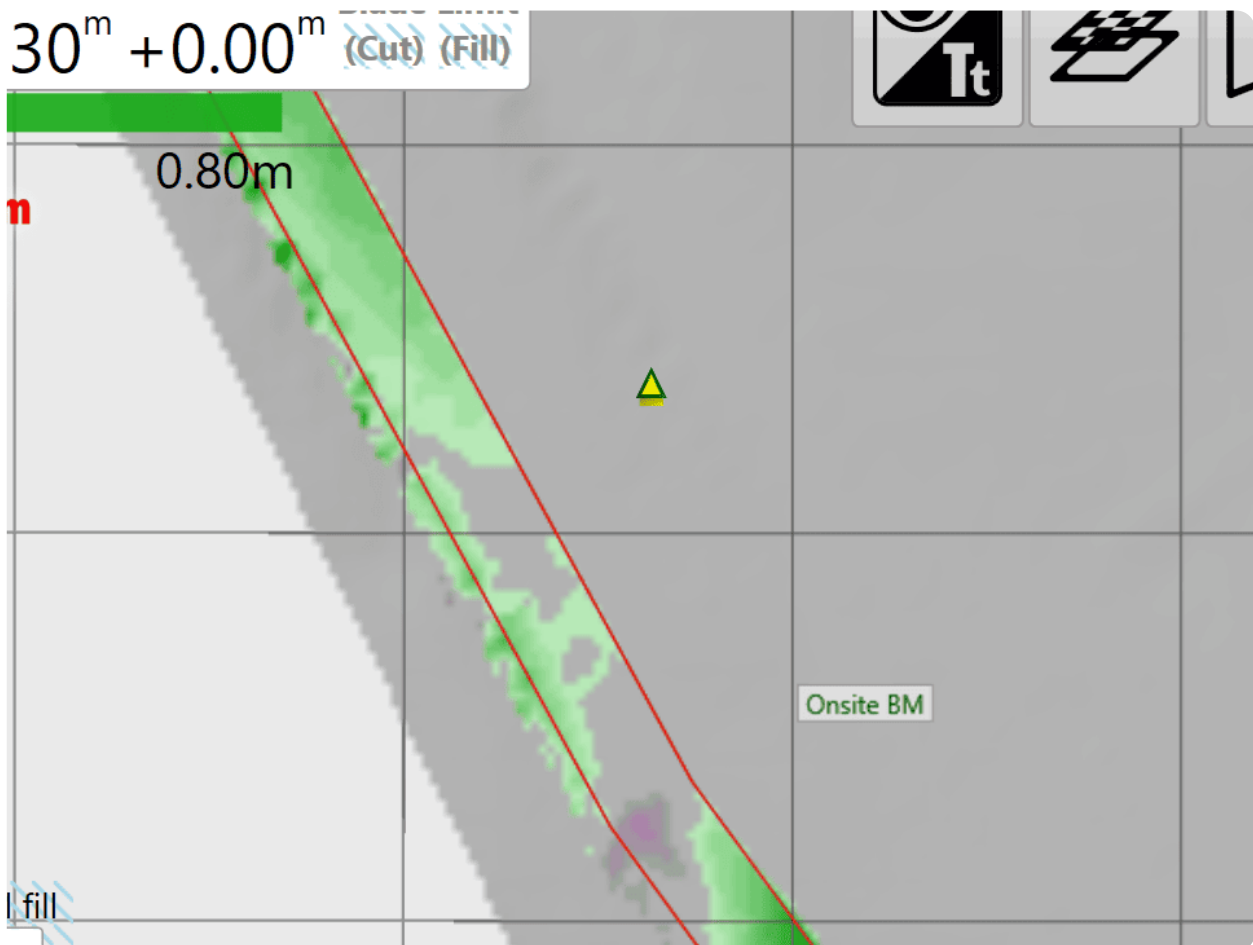
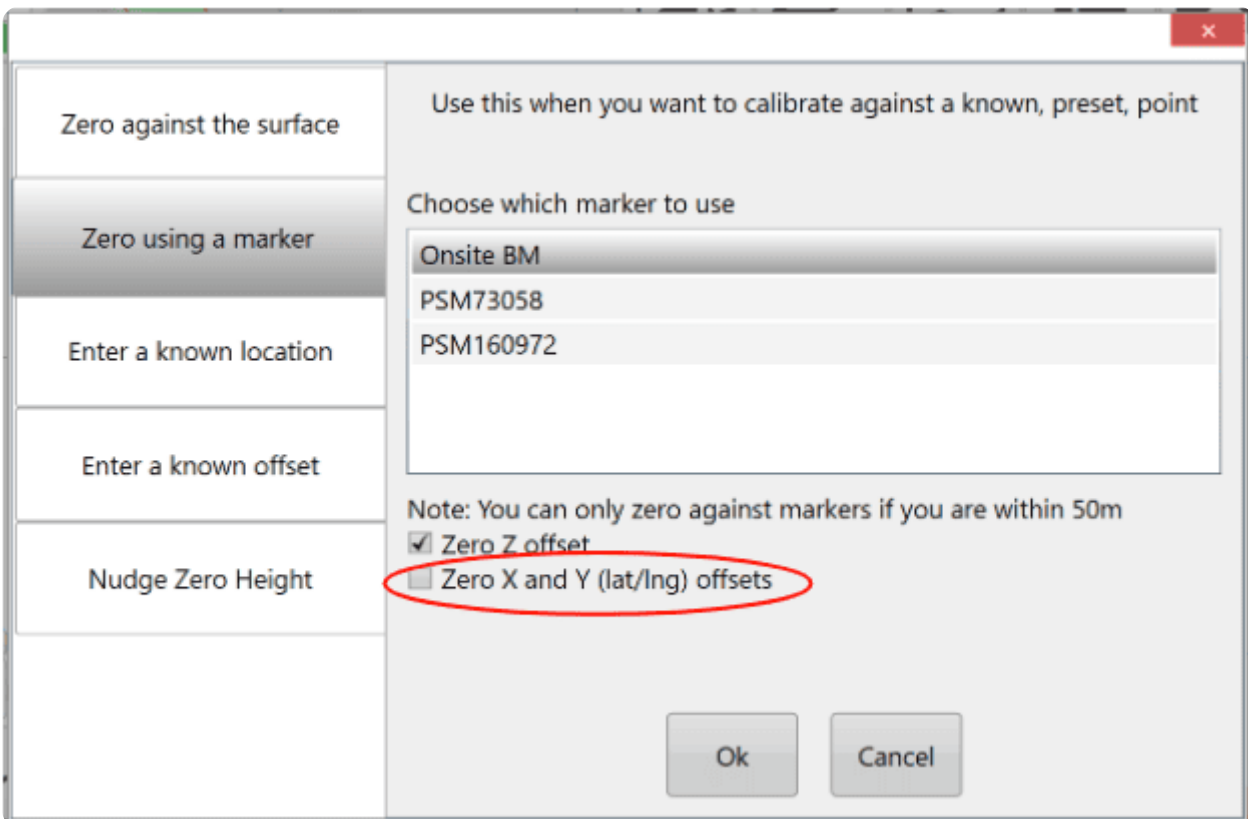
You are parked over a physical benchmark and want to adjust the map location so that the related on-screen benchmark icon matches the location on the tractor icon. However when you perform the “Zero using a marker” action nothing changes. The icons for the benchmark and the tractor remain separated.

You have forgotten to check the “Zero X and Y (lat/Ing) offsets” box.

Check the “Zero X and Y (lat/Ing) offsets” box before pressing the Ok button.

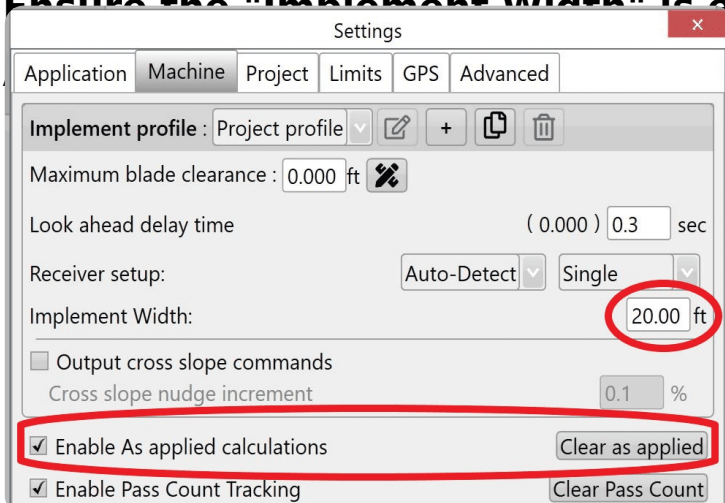
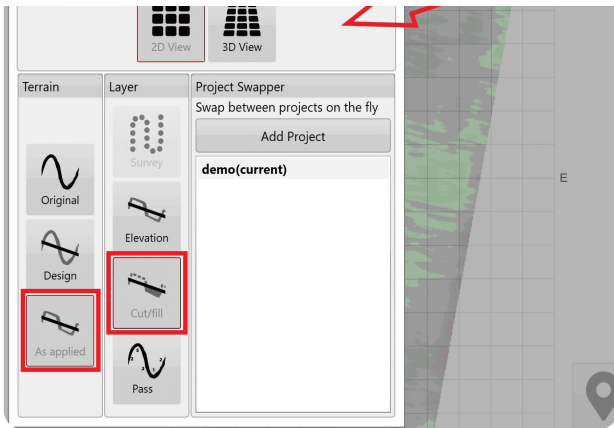
When on the implementation screen, the "As-Applied" Cut/Fill map was not updating as per pass on the field.

Ensure the "Implement Width" is entered and they have "As -

If "Implement Width" is entered and "As -Applied" is enabled, make sure you have selected in "View Settings" the "Terrain" As-Applied and "Layer" Cut/Fill maps. If 'As Applied' button is unavailable, it is a good indication that As Applied is disabled in Settings.

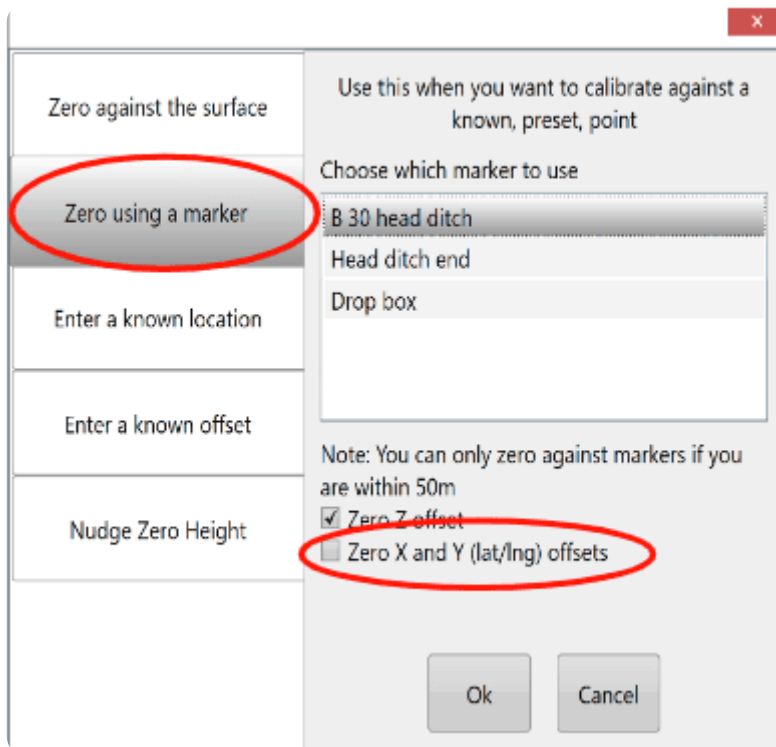
When you return to an existing job the map is no longer aligned with the position of the tractor. The project surface has moved North/South or East/West.

- **Previously entered offsets have been cleared under the Machine tab in settings.**
- **The Base station has been moved.**
- **The Base station is configured as a Quick survey and has been power cycled or reset.**

1. **Keep a record of any horizontal offsets you have used for a project in case you need to re-enter them. If you look back in the project 'activity log' you may be able to find previously entered ones there (depending on version).**
2. **Always use a Base configured as 'Absolute Base' where possible**
3. **Reference any newly established base station from a "dealer network" or permanent base network where possible**

4. **If using a 'Quick Survey' have it connected to a permanent and always-on power source for the entire duration of a job.**
5. **Never move a Base station position during a job.**
6. **Establish permanent "benchmark" locations to check against and re-align the job. You can use the regular 'Zero' button in the implementation screen for this.**

7. **Use T3RRA software offsets to re-align the map.**

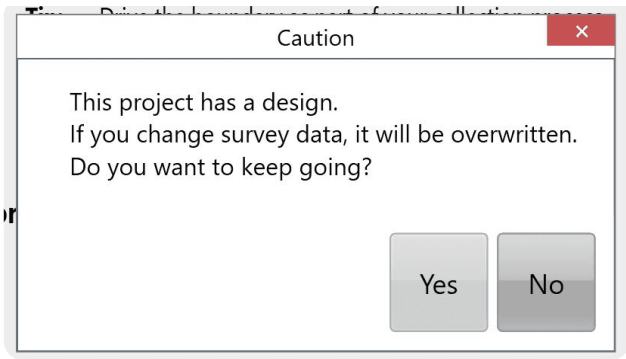
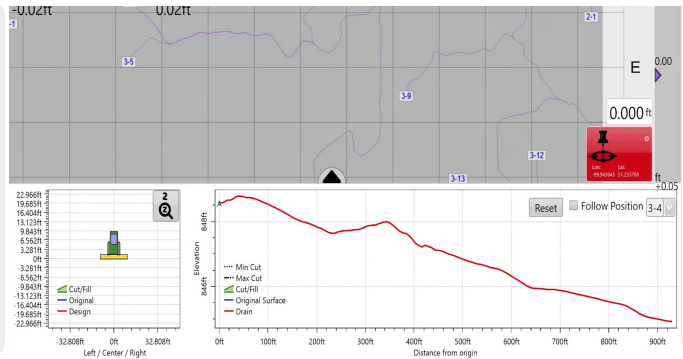
The Cut/fill map of drain surface in the Apply step is representing no cut and no fill.

The profile view in the Apply step of the drain is a solid red line.

A drain design was created for one or more of the multiple drains in one project and the user went back to the Collect step and recorded another drain survey within the same project.

All drain designs were 'overwritten' when returning to Collect step to add more drains to the same project.

Design and Implement one drain at a time saving each as one project file.

Design and Implement each drain completely within one project before adding more drains.

Survey all drains, design them, and finally implement them without returning to add more drains.

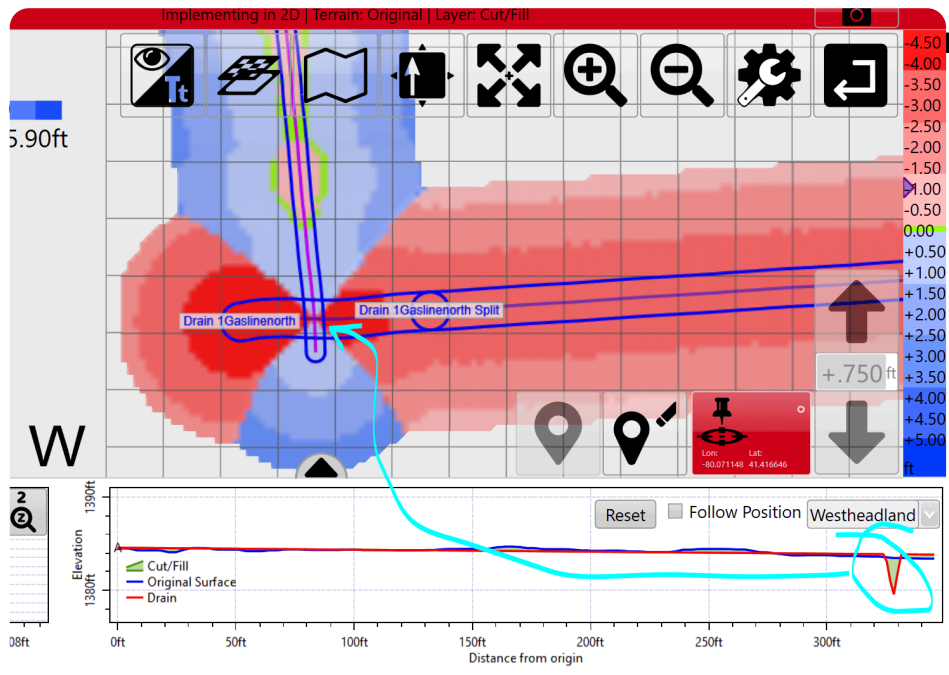
A drain line was created with a set profile but when implementing it seems to have unexpected deviations.

Multiple drains were designed and have overlapping sections. The profile of a subsequent

Design and implement one drain at a time. That way you will get exactly what is shown in the design step (if you always implement

on the original surface for instance)

In the design step apply each drain individually rather than choosing the 'Apply all' option. Each subsequent drain should use the 'Design surface' as the surface to apply on rather than the original surface. In this way you are designing the drain profile on a surface that accounts for the effect of previous drain lines. Note that the order of drain design matters in this case.

Drive survey of drains individually instead of driving one drain to inevitably need to 'split' the drain where overlapping another drain.
