Surveying issues

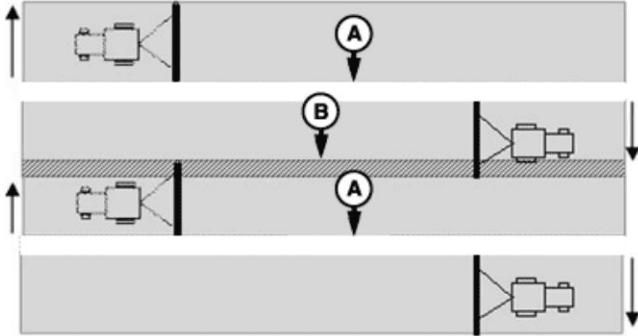
Recorded elevation data collected while surveying is offset and not in the correct location.

- **StarFire Receiver needs calibrated.**

IMPORTANT: Vehicle must be on a hard, flat level surface for calibration. If TCM is not calibrated on a level surface or TCM mounting angle is not level in relation to vehicle angle (StarFire mounting bracket or vehicle cab being slightly offset, uneven tire pressures from one side to other, etc.) operator may see offset during operation. This offset could look like a consistent skip (A) or overlap (B) in pass-to-pass operation. To eliminate offset, re-calibrate on a level surface, drive down a pass, turn around and drive down the same pass in the opposite direction. If the vehicle does not follow the same pass, measure the offset distance and enter in the implement offset. After initial calibration of TCM, it is

A—Skip

B—Overlap

- **Calibrate receiver's TCM (refer to John Deere SF OM)**
- **Re-Survey**

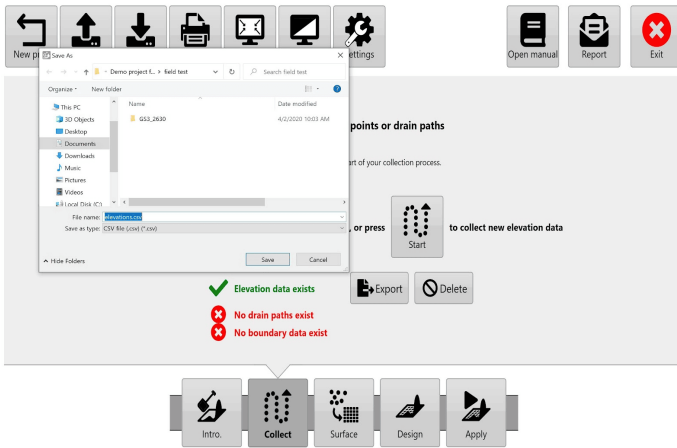
Drain line is present in the elevation data path.

T3C user has recorded in Drain survey mode instead of Field survey mode as intended. Drain lines are in a swath pattern across the field.

- 1. Delete drain line T3RRA Design (T3RRA Cutta owners only).**
 - 1. Load the project into T3RRA Design**
 - 2. Delete the drain line on the Guide tab**
 - 3. Export a control file for T3C**
- 2. In Collect step of Wizard:**
 - 1. Export data as CSV file**
 - 2. Import CSV file into T3RRA Cutta v2.**

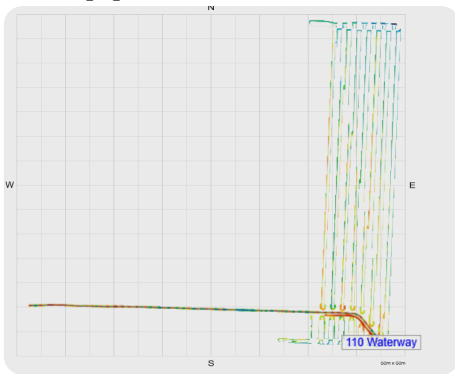
1. **When you survey a field or drain and the elevation points are faint with black lines through them causing the survey to appear incorrect or with void like spaces.**

1. **The elevation points have been recorded using the Boundary mode instead of the field or drain survey modes**
2. **Drain was resurveyed without starting a new project or deleting previous surveys.**

1. **Delete the black boundary line using the delete boundary option in the boundary survey mode in the collection screen. After this the elevation points can be used as they normally would.**
2. **Delete the unwanted drain survey elevation data in the collection screen.**
