# Baud rate is set correctly but messages from iGrade are still garbled.

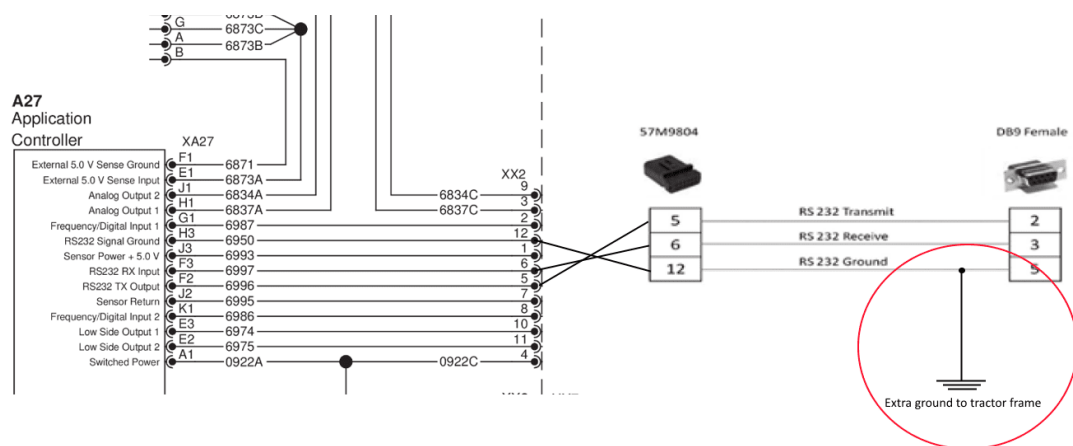
**The serial connection is not properly grounded. Pin 5 is disconnected or connected to the wrong pin at the other end of the cable.**

**Carefully check the remote control cable and the iGrade harness. Ensure that the ground wire is properly grounded. In at least one case we have had a user report that an additional grounding wire was required as shown below.**
