Elevation Offset during surveying.

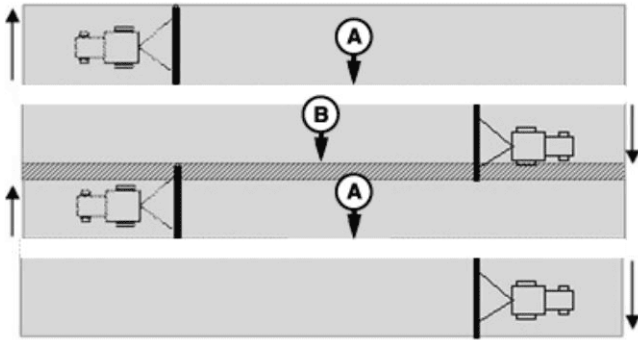
IMPORTANT: Vehicle must be on a hard, flat level surface for calibration. If TCM is not calibrated on a level surface or TCM mounting angle is not level in relation to vehicle angle (StarFire mounting bracket or vehicle cab being slightly offset, uneven tire pressures from one side to other, etc.) operator may see offset during operation. This offset could look like a consistent skip (A) or overlap (B) in pass-to-pass operation. To eliminate offset, re-calibrate on a level surface, drive down a pass, turn around and drive down the same pass in the opposite direction. If the vehicle does not follow the same pass, measure the offset distance and

A—Skip

B—Overlap

enter in the implement offset. After initial calibration of TCM, it is not necessary to calibrate again unless TCM angle in relation to the vehicle has changed. For example, tire pressure has been lowered on one side of the vehicle.
