Implement blade moves to an extreme position when placed in Auto.

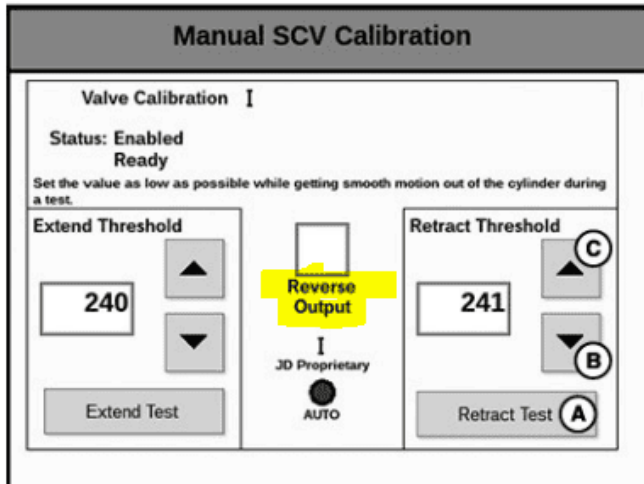
When placing the machine in Auto, the implement's blade dives deep, climbs to full height, or tips fully to one side.

SCV hoses are incorrectly configured (reversed).

UCC2 with JD proprietary mode configured for SCV control but JD Legacy "Option connector" is also connected to the tractor.

Short of altering the hydraulic hose configuration on the implement's cylinders, there is no known solution for iGrade v1. iGrade v2 also gives the option of reversing the outputs.

Ensure Option connector on rear of machine is disconnected, Then complete 2X power cycles to reset the SCV Controller
