There is an ‘offset’ cut area beside my drain.

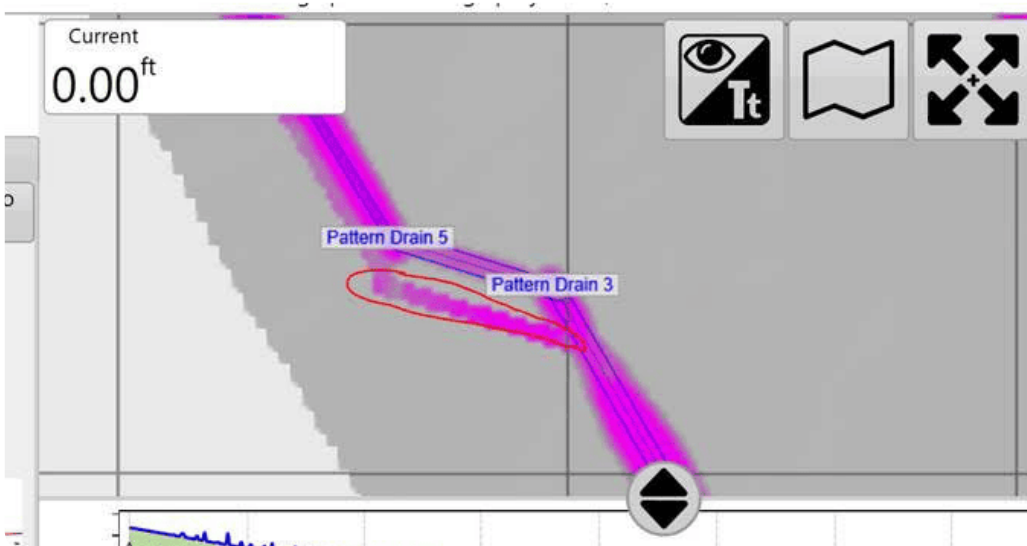
When burning a drain profile into a surface, one or more side cut areas appear that seem disconnected with the actual drain path.

Increase the batter angle, or smooth the field surface before creating the drains (and create the drains based on the DESIGN, not the ORIGINAL surface). Alternatively, simply ignore the offset cut area.

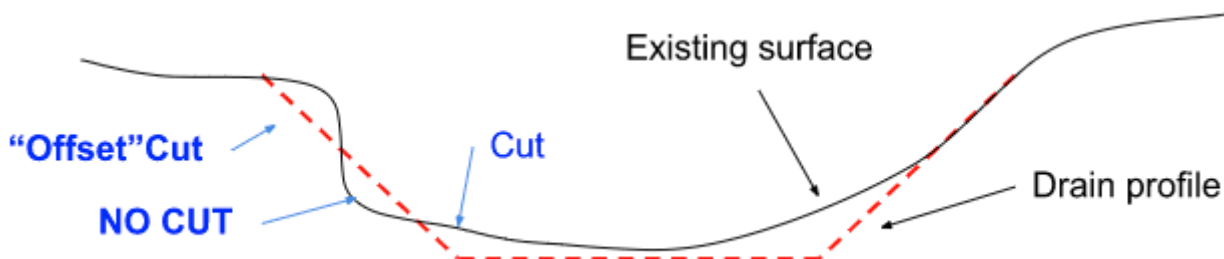
The side batter from the drain rises up through an existing surface that undulates in such a way that both cut and no-cut areas result.
