GPS issues

November 2026

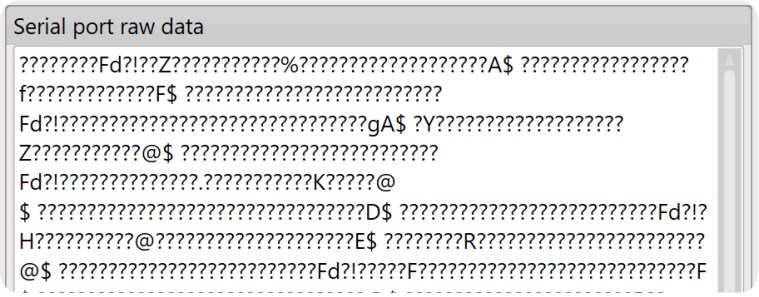
Symptoms of incorrect baud:
Incorrect baud rate settings are identifiable by viewing the incoming data in the window provided in the GPS setting tab.

Good data looks like normal text, as below.

Incorrect baud looks like:

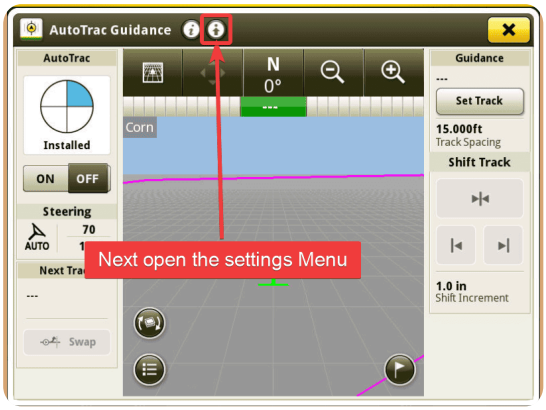
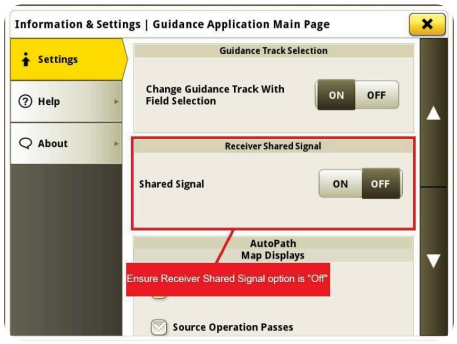
Symptoms:
Tractor position icon not appearing on map-screens.
'GPS info' button in the bottom right of map-screens is red.
In the 'Settings' window there are no characters streaming into the 'Serial port raw data' window in the 'GPS Port Settings' tab.

Causes:
The port for the GPS to T3RRA software may be closed.
Signal sharing is causing iGrade to lose Gps
Drivers for tablets serial port or USB-to-serial port may not be up-to-date.
Cables may not be seated correctly.

1. Ensure all Windows updates are performed.
2. Open the GPS info screen by pressing on the GPS button in the bottom right of the Collect or Apply step. Confirm that you have an RTK GPS signal and that the Open Port button is grayed out.
3. Ensure Signal Sharing is disabled in Autotrac settings

4. Confirm USB-to-serial cable's driver is up-to-date if applicable (refer to 'Access to the port 'COM X' is denied'. for instructions on how to update driver)
5. Confirm harnessing is correctly installed using AE3166 to connect T3RRA to iGrade app controller or AE3070 to T into receiver for surveying without iGrade.
6. Perform a continuity check on the iGrade harness to make sure the pin configuration is correct and the cable is not damaged.
7. Check settings in both iGrade and T3RRA (iGrade and T3C need identical Baud Rate):

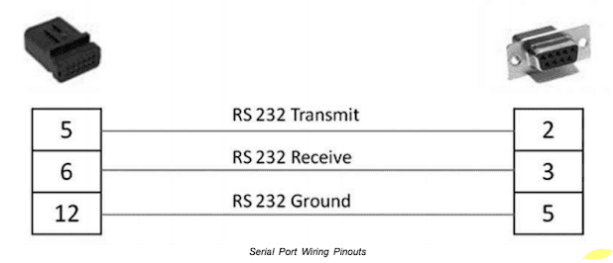
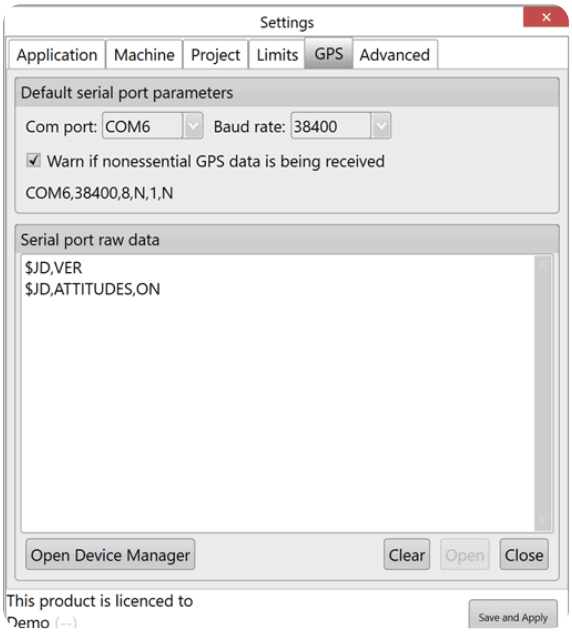
Testing Serial harnessing.

The serial port raw data should populate the messages as indicated below, this would indicate both the send and receive pins are working correctly and the harnessing is connected correctly.

VERY CAREFULLY! connect the transmit (TXD) signal to the receive (RXD) signal pins 2&3 on the serial port connector. Or pins 10&3 on the JD SF Receiver connector. Or Pins 5&6 on the iGrade connector.

While these pins are connected, press the **Open Port** button.

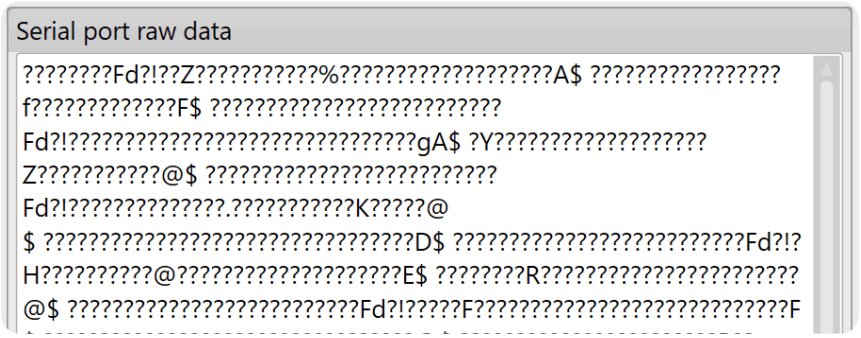
Symptom:
The Tablet PC running T3RRA Software is connected directly to GPS but it is not receiving a GPS data stream.

1. The GPS receiver is not properly configured to output data via serial.
2. The cable between GPS and tablet is not connected or defective.

1. Check your receiver settings to ensure the correct data strings are being sent to the appropriate port.
    a. NMEA GPGGA @ 5 Hz
    b. NMEA GPGSA @ 5Hz
2. Check your receiver settings to ensure that the baud rate in use matches that expected by your T3RRA software. The rates configured in each must match.
3. Check your cabling.

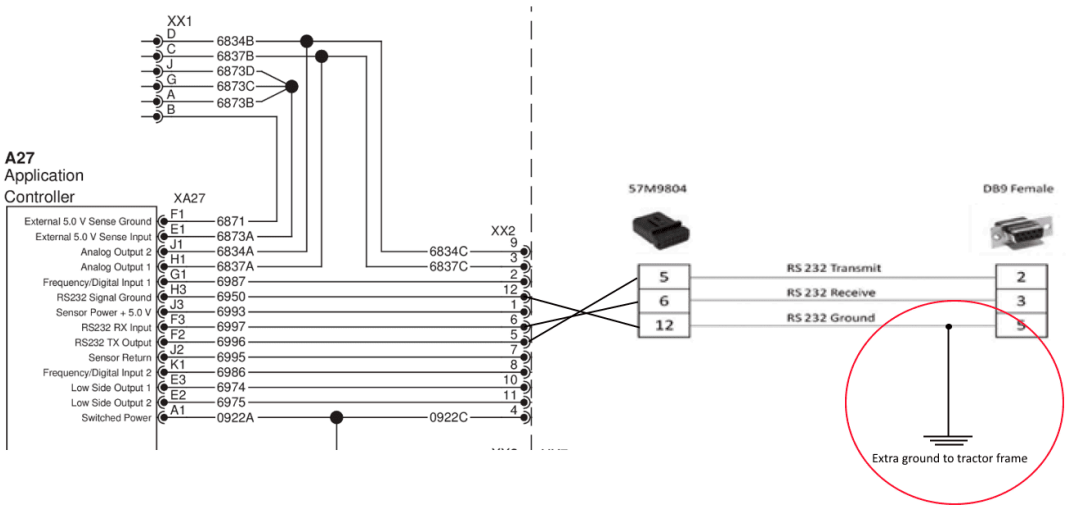
Symptoms:
Baud rates are set correctly on both T3RRA software and in iGrade. The T3RRA software is not receiving GPS and the GPS diagnostics window is showing an unintelligible data stream.

Causes:
The serial connection is not properly grounded. Pin 5 is disconnected or connected to the wrong pin at the other end of the cable.

Solutions:
Carefully check the remote control cable and the iGrade harness. Ensure that the ground wire is properly grounded. In at least one case we have had a user report

that an additional grounding wire was required as shown below.

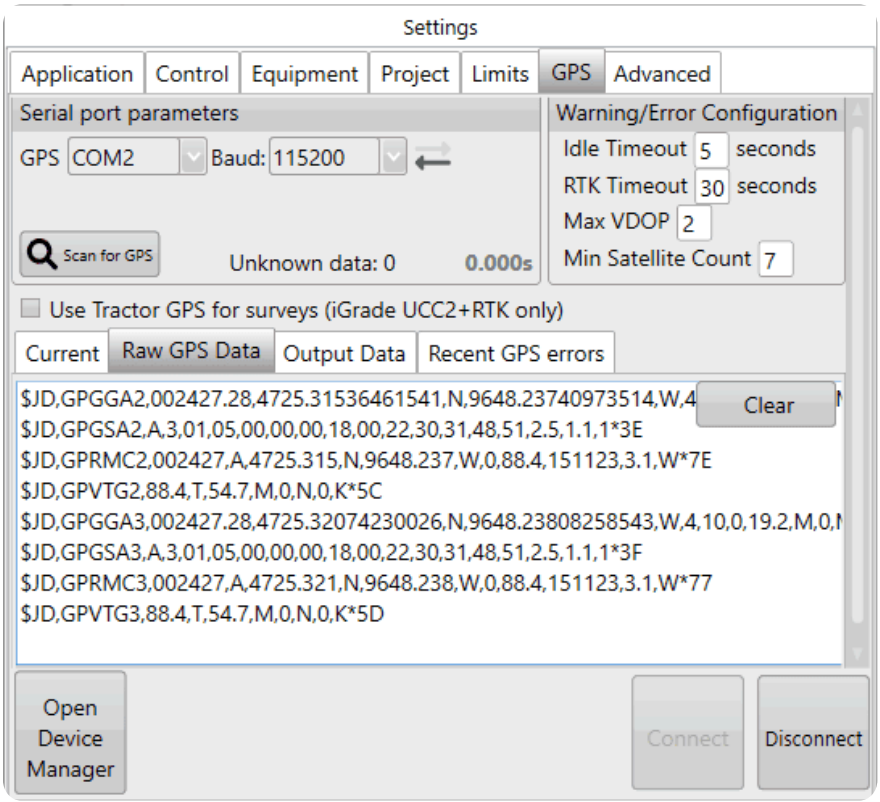
When you open a COM port you clearly see that positional data is being received. However the GPS Info window is displaying a fix other than

FixedRealTimeKinematic.

1. You are connected to the wrong COM port. This is possible if your tablet has an internal GPS and you are connecting to its port.
2. Your GPS is not receiving RTK correction packets from its base station.

1. Check to see that you are connected to the correct serial port.
2. There are many reasons a GPS may not be receiving correction packets from its base station. Check your GPS documentation for solutions.
