Implementing issues - iGrade alone

Implementing issues with iGrade (will occur without T3RRA connected)

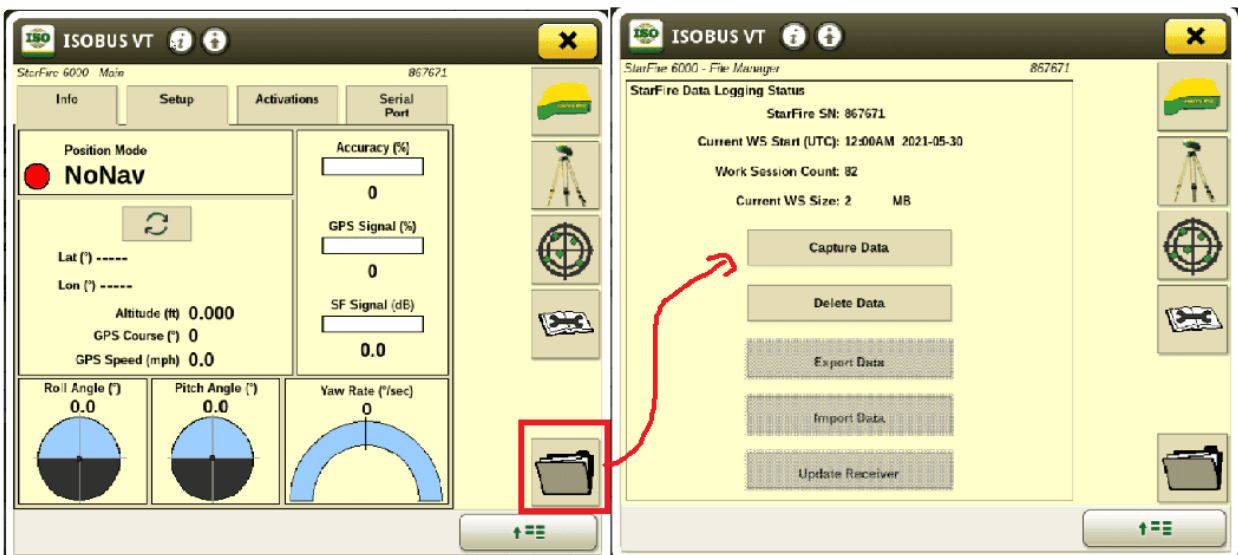
NOTE: There will be situations where your dealer may ask you to capture a StarFire message log for further diagnosis. This can be done on the Deere display using the SF6000 VT as follows:

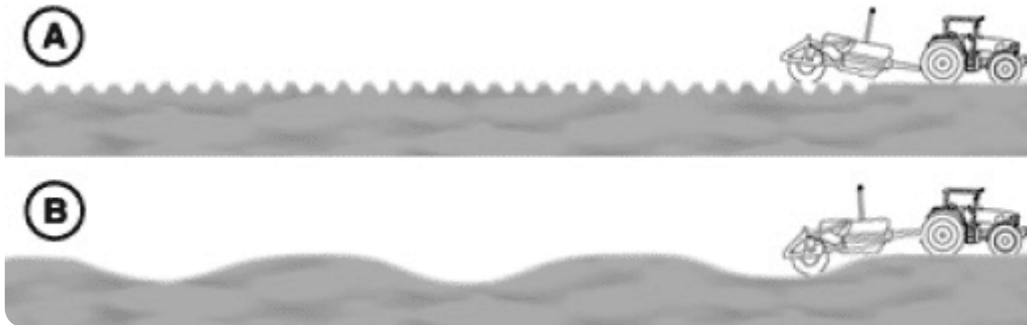
Scraper causes a washboard effect.

A-If washboarding is close together, flow rate is too high.

B- If washboarding is far apart, flow rate is too low.

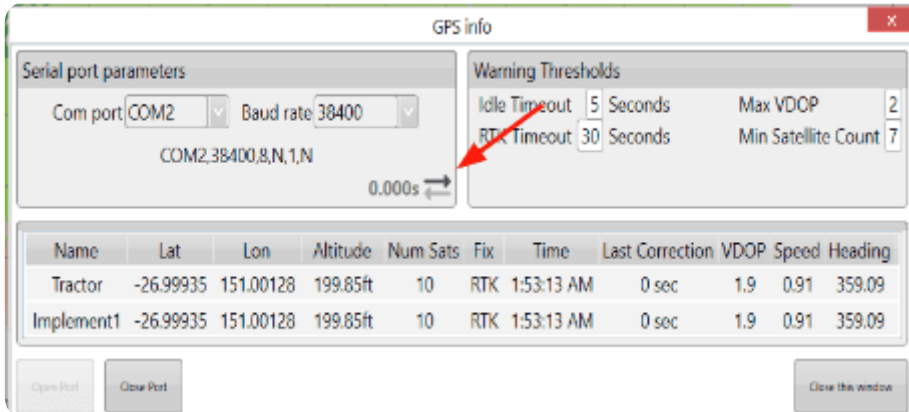
1. **Check that you are in the ‘Implementation’ screen in your T3RRA software, and that you have pressed on the ‘Start’ button.**
2. **Check that the T3RRA software is not in ‘Demo’ mode.**
3. **Check that the data sending spinner is rotating (T3RRA v1) or the send arrow is flashing (T3RRA v2).**

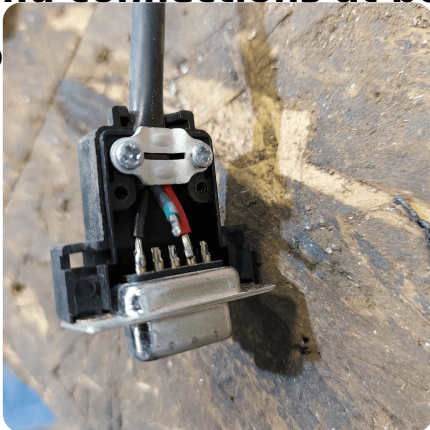
4. **Check that your iGrade Remote Control Harness is in place and connections at both ends are well seated, and that no pins are damaged/pushed-in.**
